# Furious weather

BASS STRAIT HAS SOME OF THE MOST DANGEROUS WEATHER ON THE PLANET, BUT LESSONS ARE LEARNED FROM THE EXPERIENCE. **CHRISTINE DANGER**

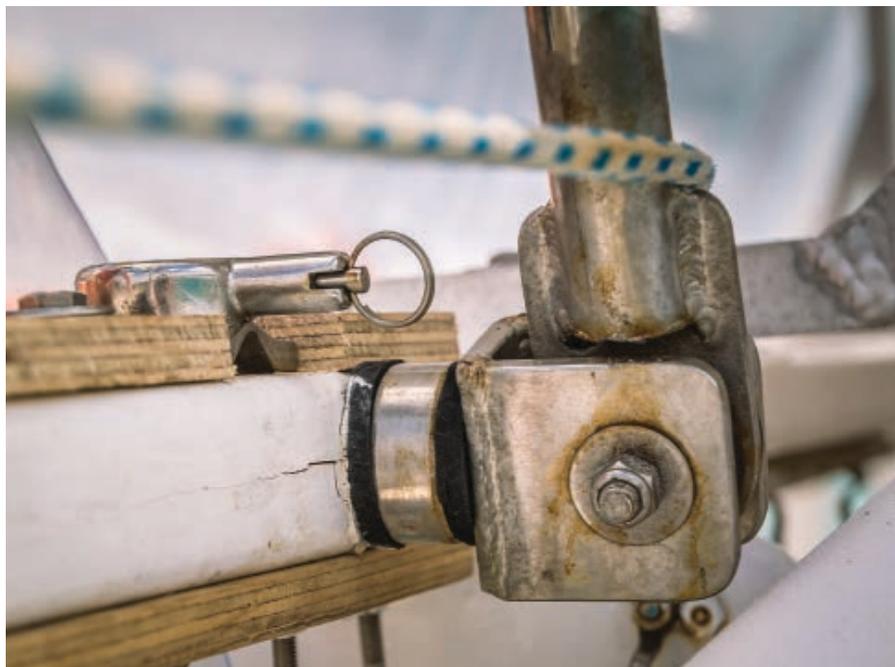
**FROM TOP:** Makeshift repair to the cracked frame supporting the struts, the solar panels and the davits.

Things were a bit more under control by then and we could survey the damage. There was a nasty crack along the frame where the struts attach, not to mention the dinghy davits and the solar cells. We needed this stabilised. Wade cut some lengths of wood with a hand saw, drilled some holes in it with his electric drill and bolted them on either side of the frame to strengthen it.

1. if you notice something wrong, figure out the cause and take action immediately to minimise risk. We should have done early on what we did after the incident: clamp the frame with the two strips of wood as soon as we noticed the crack in it. We should have put extra ropes to stabilise the wind generator pole and park it when we knew 40 knot winds were forecast.

We finished our cruise a month later without experiencing further problems despite continued strong winds and, once back on terra firma, were attending to repairs. We now have a brand new frame, new wind generator blades, reinforced struts and a revised high wind safety process. The hip pocket has taken a bit of a beating.

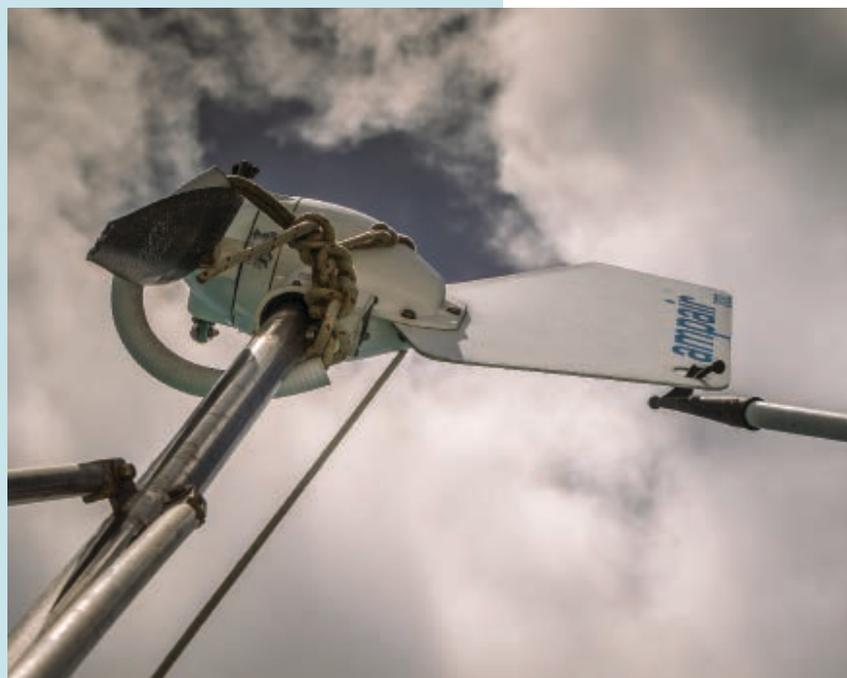
What is left of the wind generator, now parked.

The next thing I was turning away towards the stern, getting drenched by the spray; I heard a loud noise and saw these black shapes spinning away and the start of this huge pounding noise. Spectacular had just turned to ugly and scary, two of the three blades from our wind generator had torn off. The last one left was sorry looking, half mangled and the whole unit, now unbalanced, was sending fierce shakes through the boat.

The pole and struts supporting the turbine were wobbling violently and uncontrollably, making a horrible jackhammer racket, threatening to tear the whole thing off the frame to which it was attached.

It took us well over an hour to secure the last broken blade, stop it from whizzing around and tie the pole and struts down to stop them from shaking. It is hard enough to lock the blades in calm conditions, but try getting it done when it is blowing at over 50 knots and you get the picture.

2. check the wind strength your wind generator can operate at and if it looks like the wind will be close or in excess of its safe margin, park the blades. It is easier to do this before the wind picks up too much. The Ampair is rated for storm conditions but, in future, if we get a 40 knot forecast we will park the blades.
3. make the parking of the blades easier by threading a loop of rope through the eye of the wind generator tail. It would have been much easier to put the boat hook through a loop of rope than a small hole in the tail.
4. carry extra ropes, sheets of marine ply, fibreglass sheets, epoxy, nuts and bolts for any eventuality.

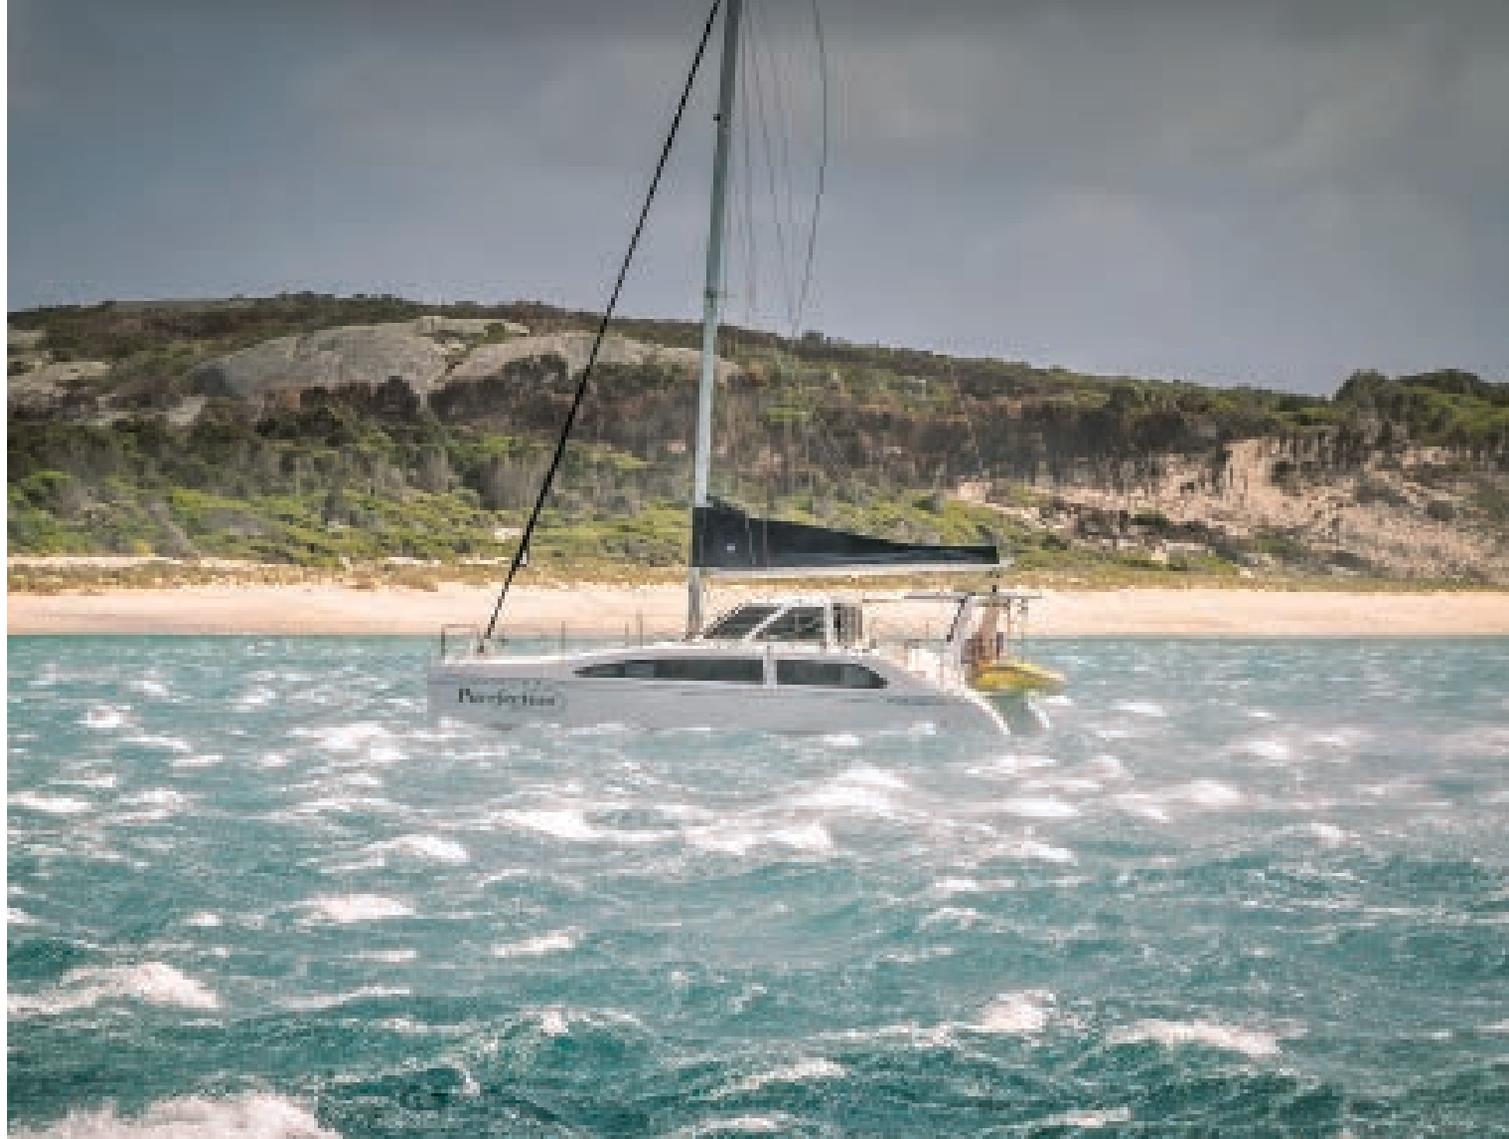
We should not have accepted a compromised construction in the first place. At the beginning of our trip, we noticed a small crack in the frame where the struts attached and thought: “we’ll have to attend to this when we get back”. In hindsight we should have strengthened the frame then and there, as soon as we saw that. The additional flex in the pole in the high wind was opening the crack with every strong gust and we had lots of strong wind throughout the cruise.

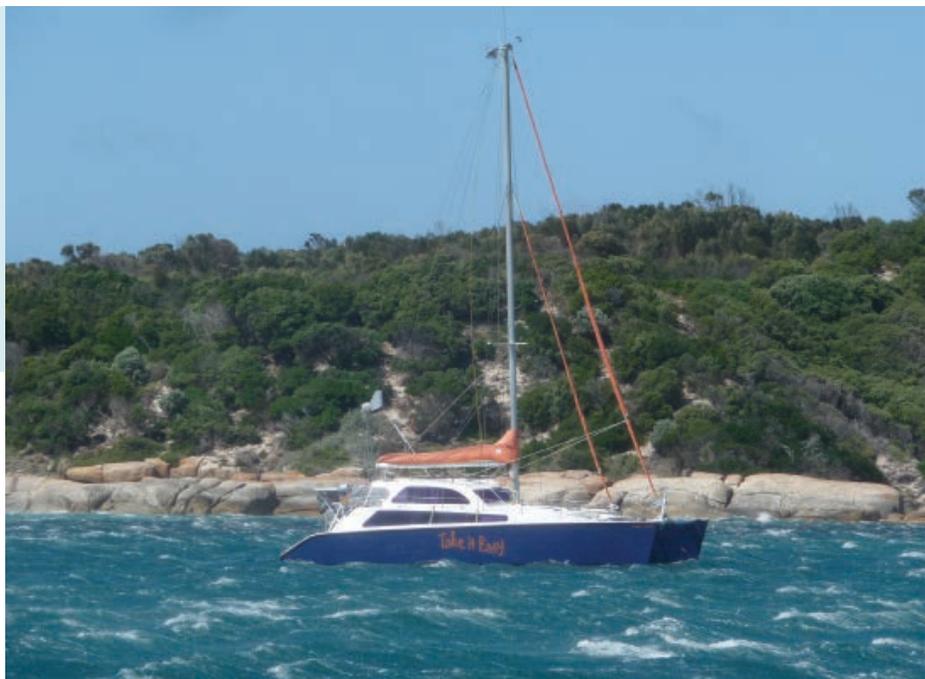
*Take It Easy* in 50 knots, after losing the wind generator blades. Image courtesy Ian on *Purrfection*.
